Exhibit 17

Building Moisture Survey

The property at 398 Augusta Dr, Telford, PA 18969 was the subject of a visual, moisture meter or an infrared (IR) survey on 2/27/2017. Areas agreed and designated by the client for this survey are listed in this document.

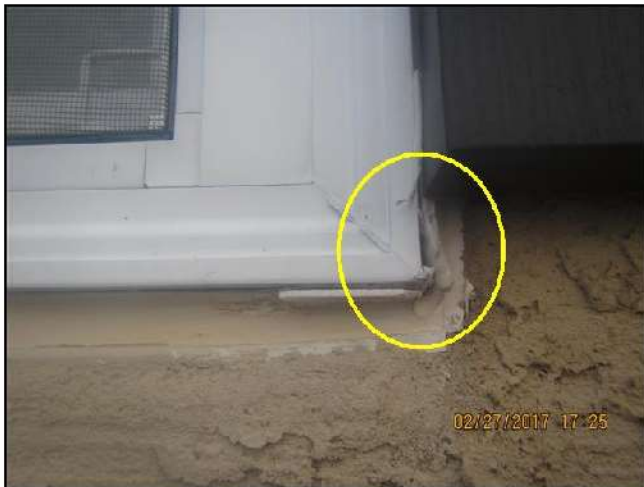
6.1 (Picture 4)

(3) The manufactured stone veneer is not adequately sealed around the windows or other penetrations.

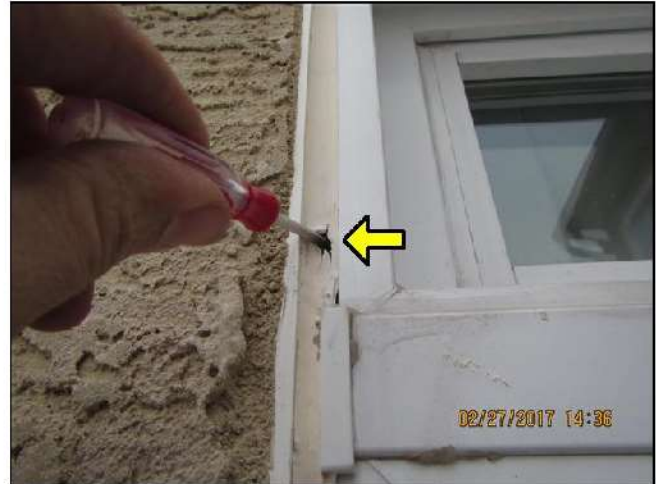
6.2 (Picture 2)

(2) The manufactured stone veneer is not adequately sealed around the doors or other penetrations.

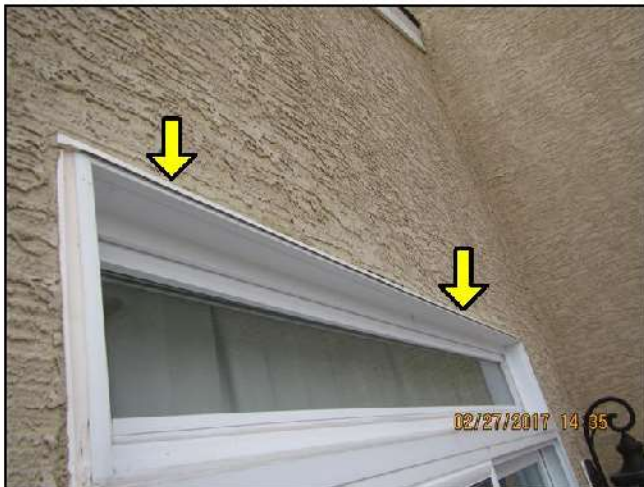
6.5 (Picture 1)

Example of installed door head flashing

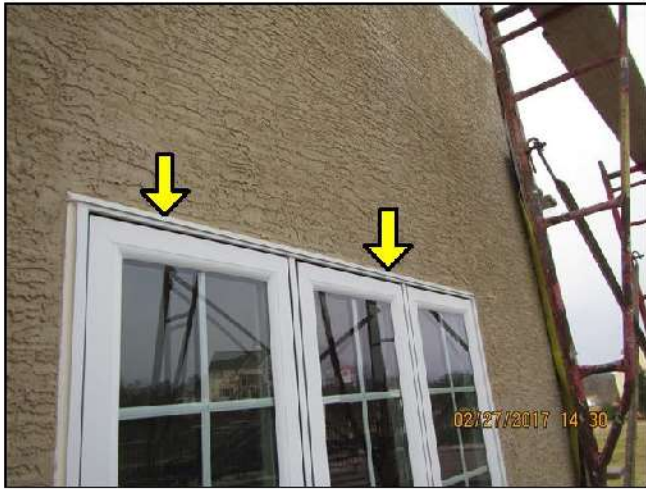
6.6 (Picture 1)

(1) Example of installed head flashing

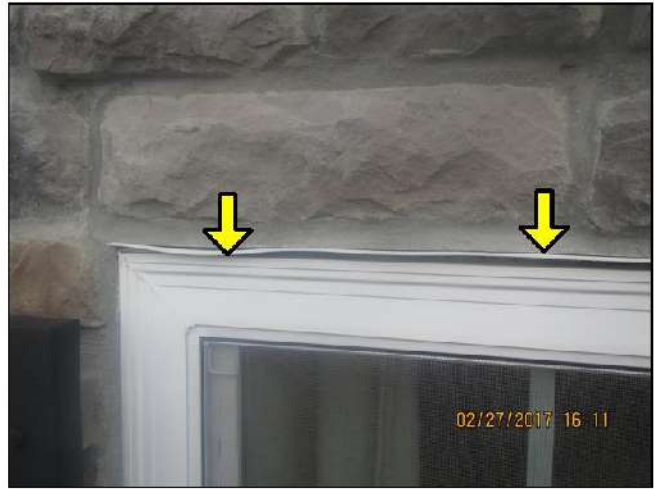
6.6 (Picture 2)

(2) Window head flashing was installed on the MSV, however it is flat and in some instances it has a negative pitch toward the home. This may force bulk water behind the cladding. Correcting the pitch is recommended or the installation of sealant end dams incorporated with proper sealant joints on the sides and bottom.

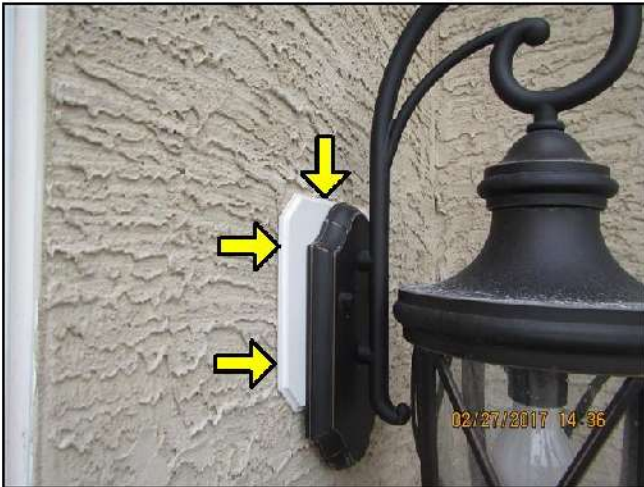
6.7 (Picture 1)

(1) The stucco is not adequately sealed around the utility penetrations.

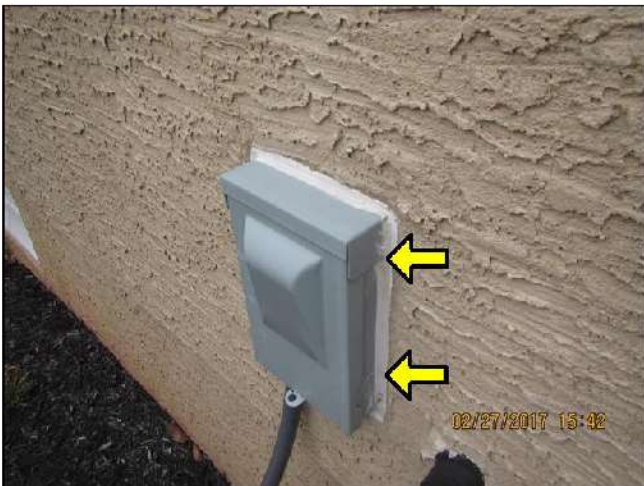
6.7 (Picture 4)

(2) Some utility penetrations have been sealed post construction.

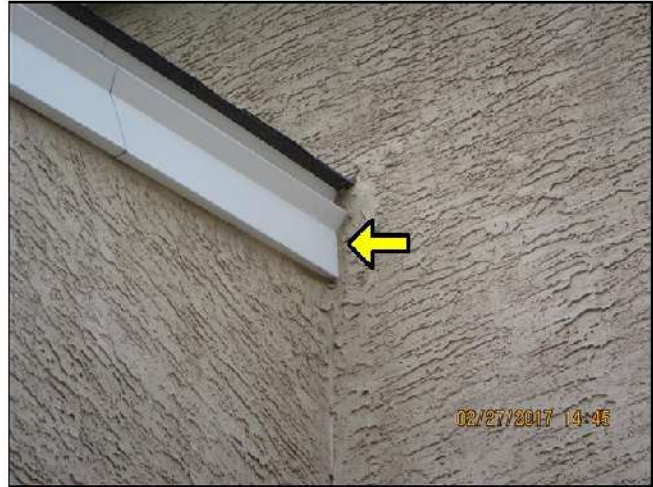
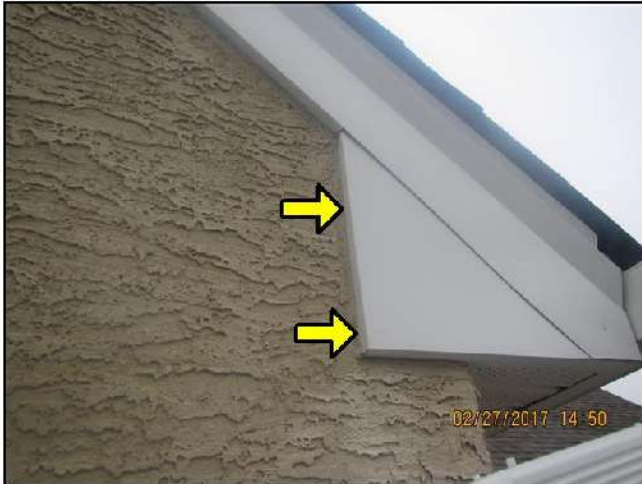
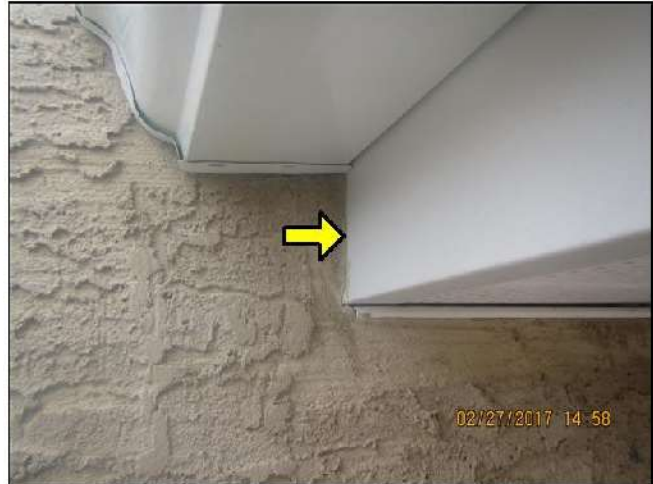
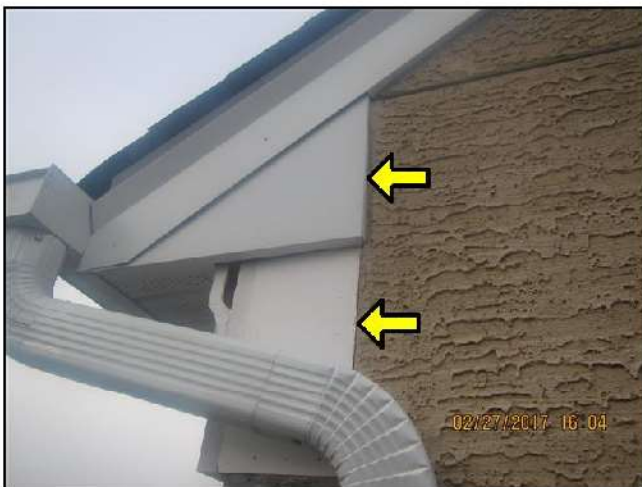
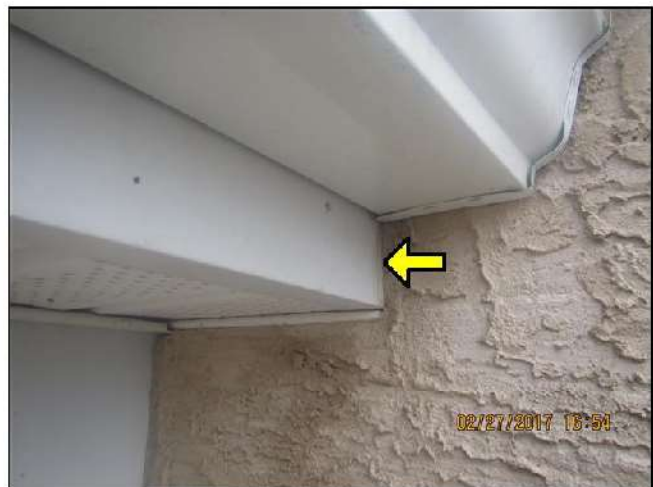
(1) The stucco is not properly sealed at the rake boards, fascia boards, soffit returns or other terminations.

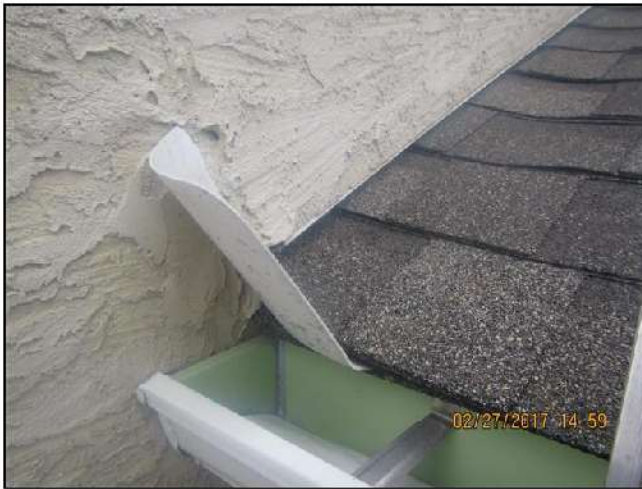
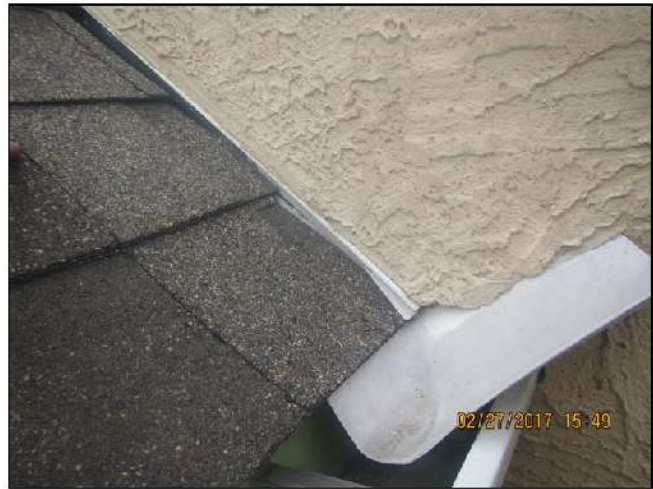
(1) Example of installed kickout flashing.

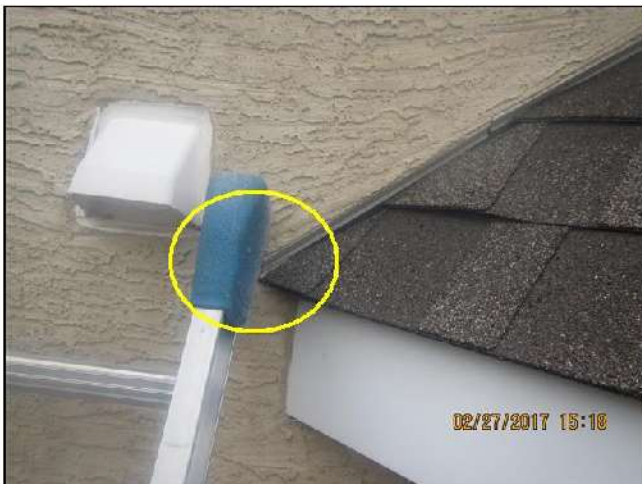
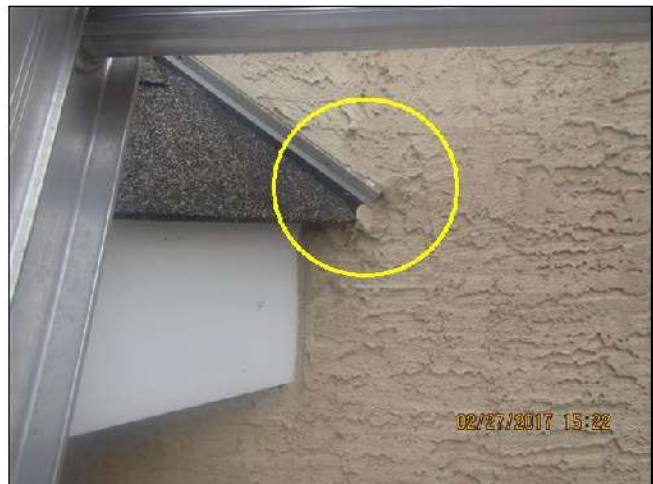
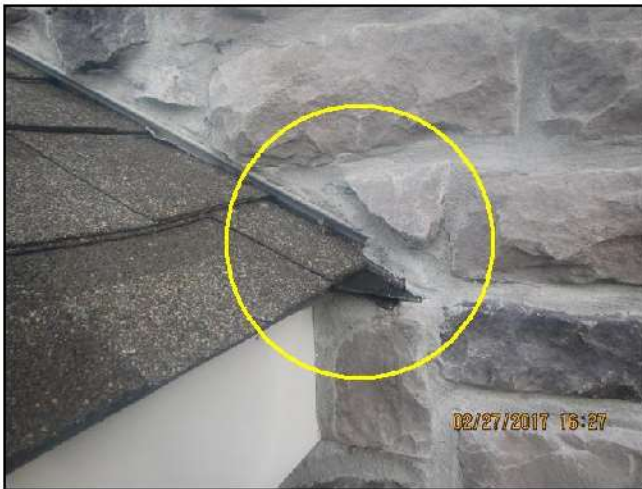
(2) Kickout flashing was not installed at the roof/wall intersections at the front of the home and the rear of the home.

Kickout flashing was not installed in some locations. Kickout flashing is a special type of flashing located at roof/wall intersections that diverts rain water away from the cladding and into the gutter. When installed properly, they provide excellent protection against the penetration of water into the building envelope. Several factors can lead to rain water intrusion, but a missing kickout flashing, in particular, often results in concentrated areas of water accumulation and potentially severe damage to exterior walls. Water penetration into the cladding can occur with little or no visible evidence on the exterior.

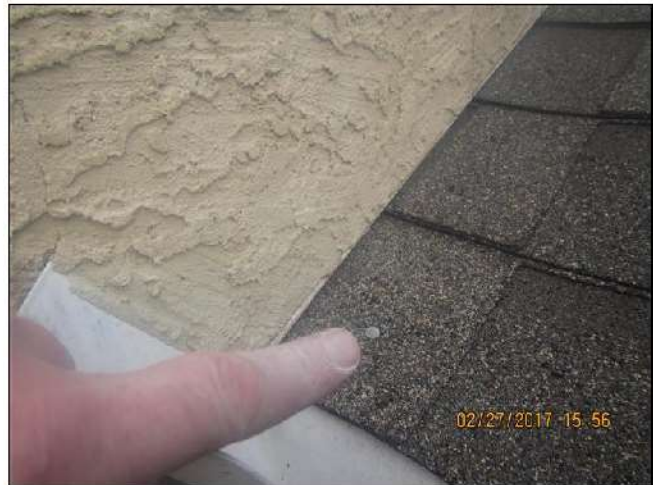
6.11 (Picture 8)

(3) A larger one piece kickout was installed over and original smaller two-piece kickout. This appears to have happened at the time of construction. It is not clear why the original inadequate kickout was not pulled when installing the new ones. That would have been a more adequate installation. A nail was noted through the kickout in a few locations. This may present a leak point. The back sides of the kickouts needs to be sealed.

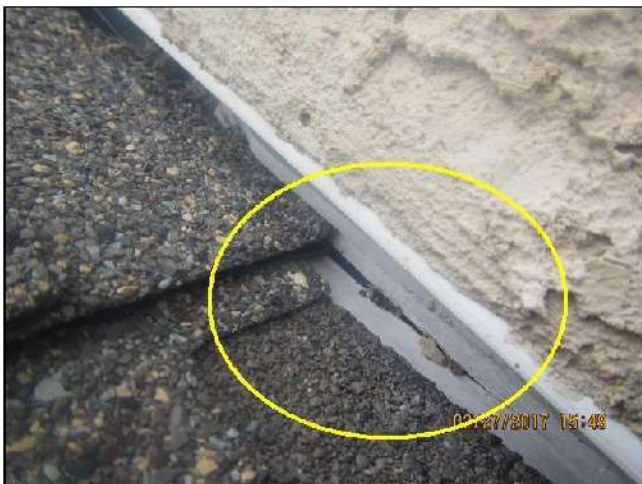
6.11 (Picture 9)

(4) One of the kickouts at the rear of the home was split at the time of installation. This may allow water bypass.

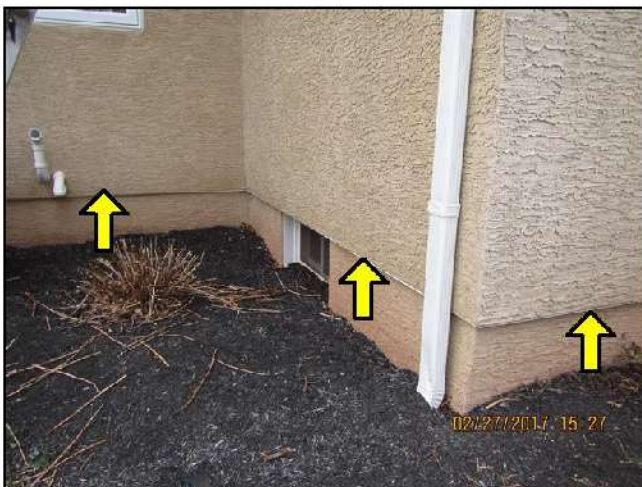
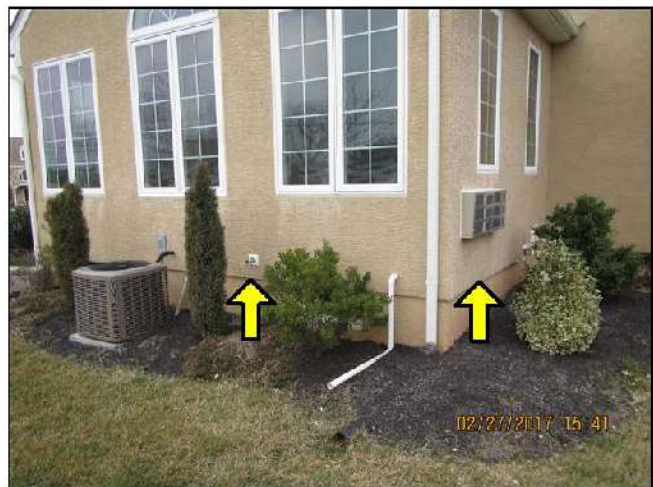
A provision for drainage or "weep screed" was installed.

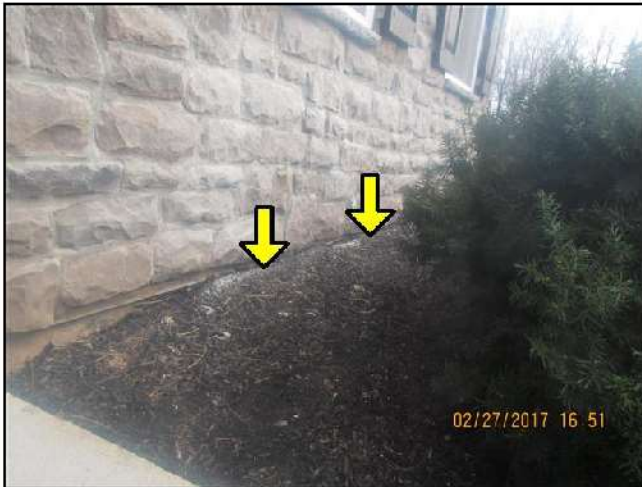
6.23 (Picture 1)

(1) The landscaping mulch is above the weep screed on the front of the home. This should be lowered to allow proper drainage.

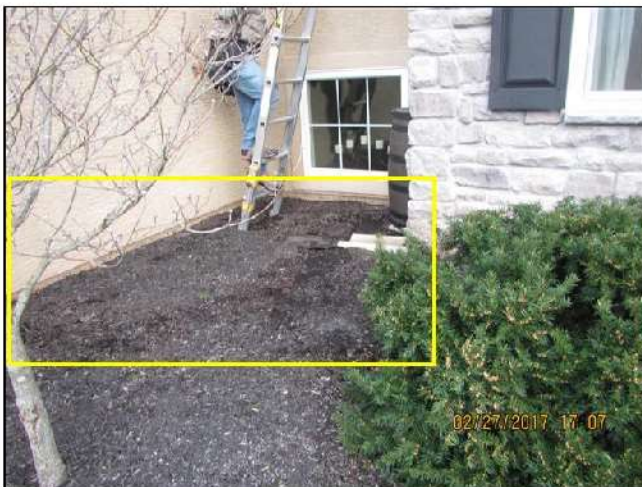
6.23 (Picture 2)

(2) The grading near the basement egress at the front of the home is lower than the rest of the landscaping, which may pool water in this area.

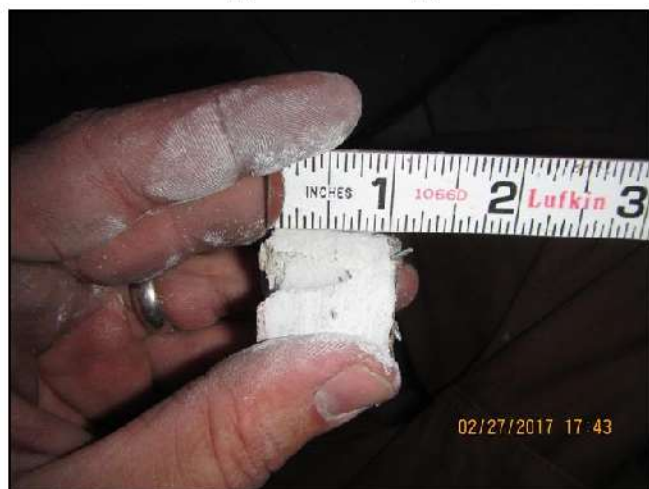
6.29 (Picture 1)

The stucco was applied at an approximate maximum thickness of 1"

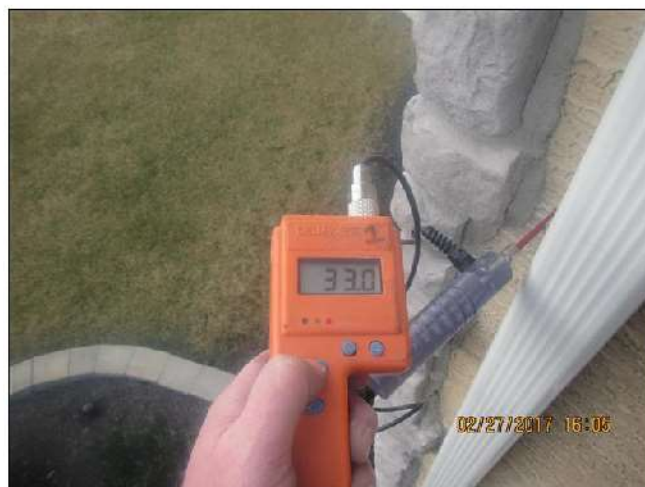
6.37 (Picture 2)

Example of elevated moisture levels noted utilizing a calibrated and insulated moisture meter.
